NATIONAL TRANSPORTATION SAFETY BOARD

MATERIALS LABORATORY FACTUAL REPORT

Report No. 21-081

Place : Pine Grove, Oregon
Date : August 23, 2020
Vehicle : Kaman K-1200, N314
NTSB No. : WPR20LA283
Investigator : Fabian Salazar, ASI-WPR

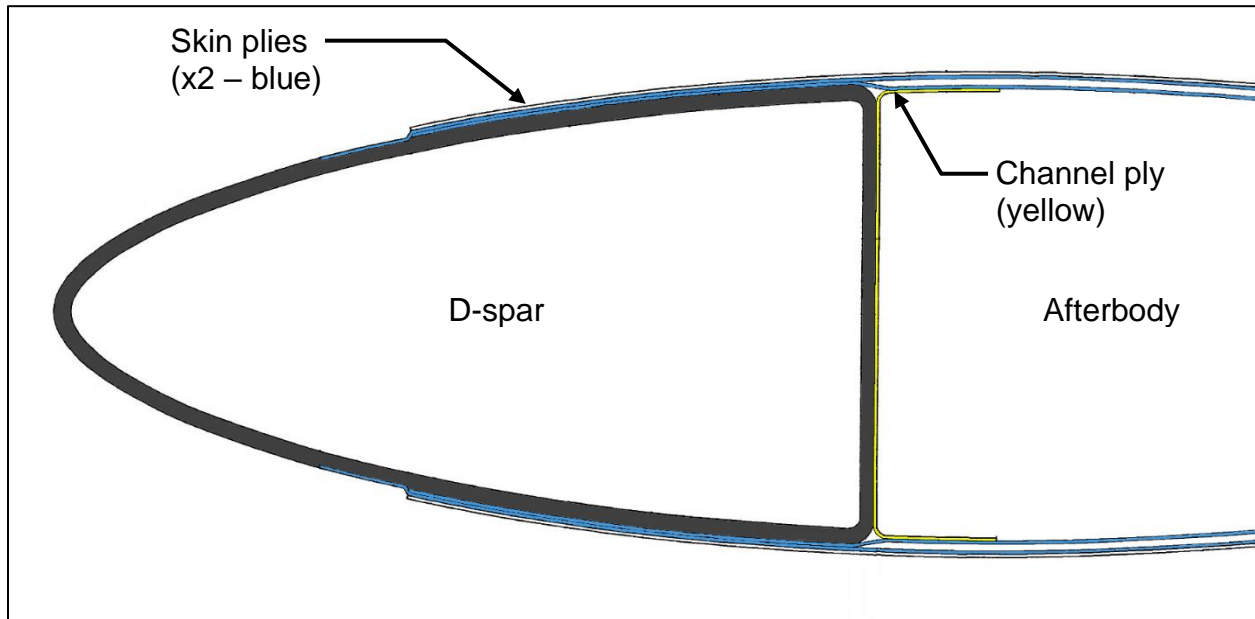
Figure 15: Cross section illustration of the servo flap at the spar-to-afterbody transition.

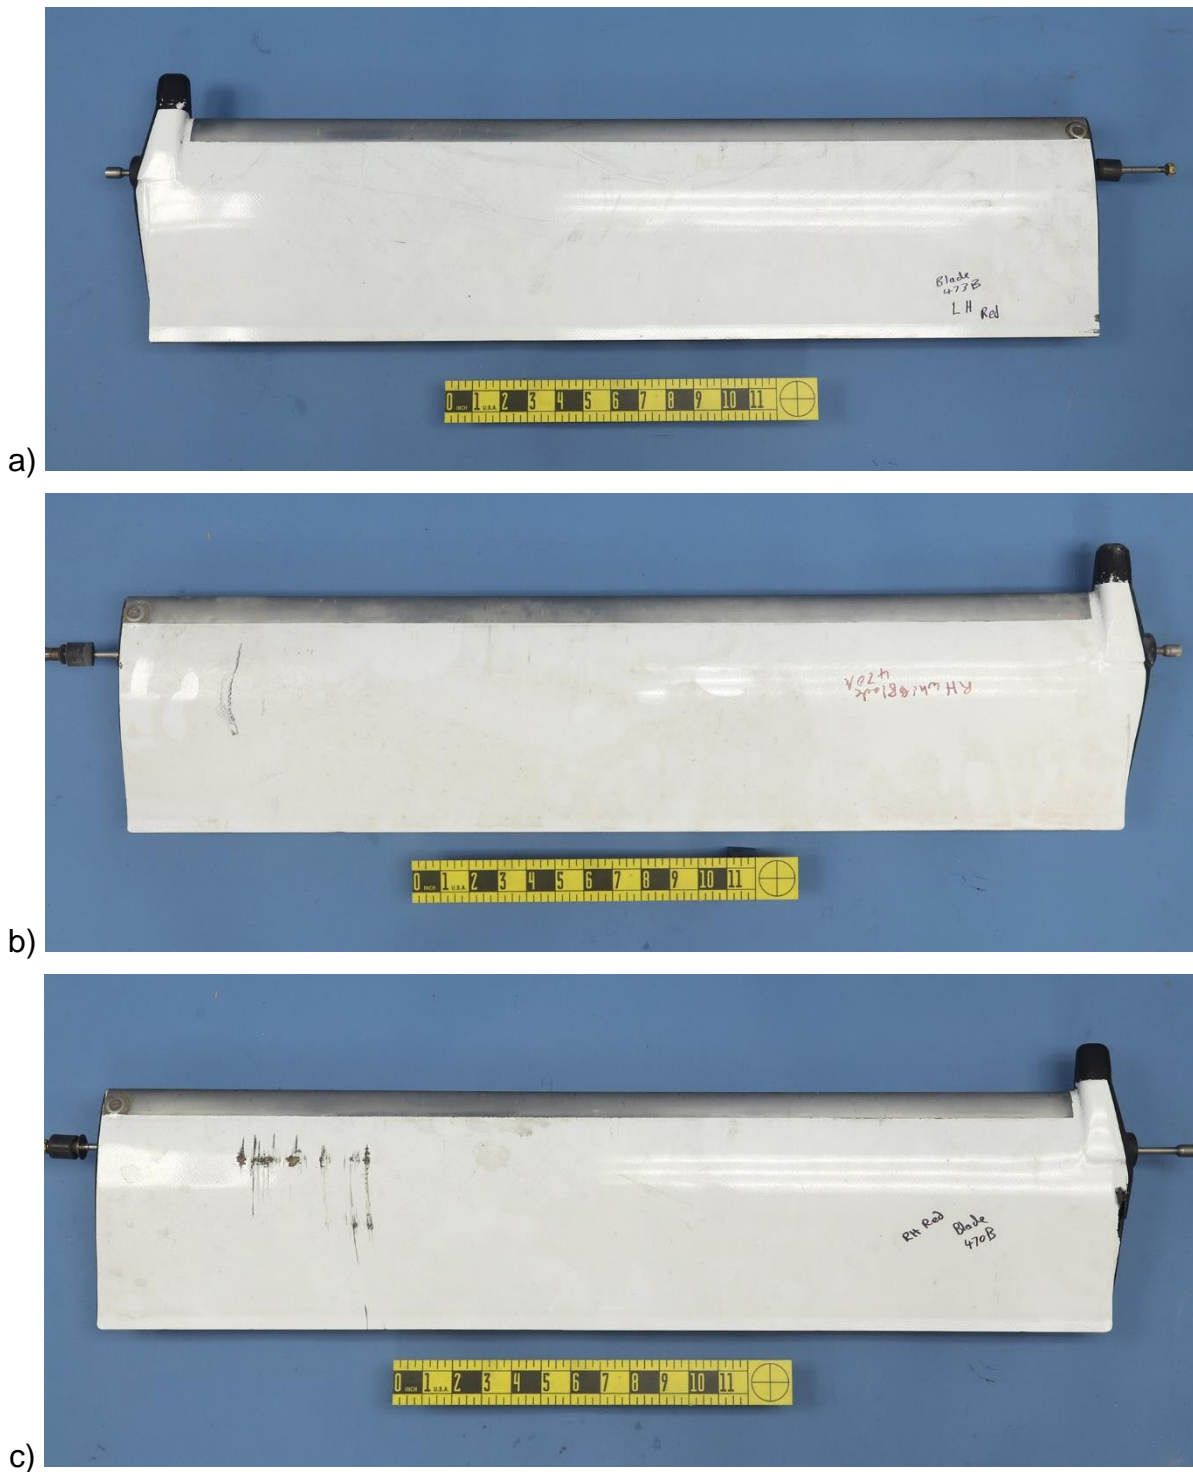
The sister flaps from the accident aircraft were examined for visual signs of cracks, particularly around the inboard closeout and the bond between the closeout and aluminum fitting was evaluated. Overview images of the LHR, RHW, and RHR servo flaps are shown in figures 37a – c, respectively. The RHR flap had indications of foreign body contact on the outboard portion of the upper skin between STA 25 and 30. All flaps exhibited cracking along the bond line between the closeout and the aluminum fitting, but the extent of cracking varied. The LHR flap inboard closeout exhibited a hairline crack that extended approximately 1 inch along the upper surface and halfway down the inboard side of the flap, as seen in figure 38. The RHW inboard closeout cracks extended approximately 1 inch along the upper surface, wrapped around the inboard side, and extended approximately 0.6 inch along the lower surface, as seen in figures 39a – c. The RHR inboard closeout cracks extended approximately 0.5 inch along the upper surface, wrapped around the inboard side along the bond line, and extended approximately 1.7 inch along the lower surface, as seen in figures 40a – c. The closeout had sustained damage as seen in figure 40b. There were holes through the upper and lower surfaces and the closeout was partially fractured between the holes. The inboard ends of the flaps were sectioned as described below. The RHR flap was cut along the red dashed line in figure 40c, which passed through a crack along the underside of the flap. The cross section through the crack, shown in figure 40d indicated that the outer and inner skin plies were fractured beneath the surface crack.

Figure 37. Sister flaps from the accident aircraft: a) LHR; b) RHW; and c) RHR
